PRODUCT: Computer Monitor BULLETIN: Monitor 95-004

MODEL: CMB5477L

SUBJECT: CRT Substitution

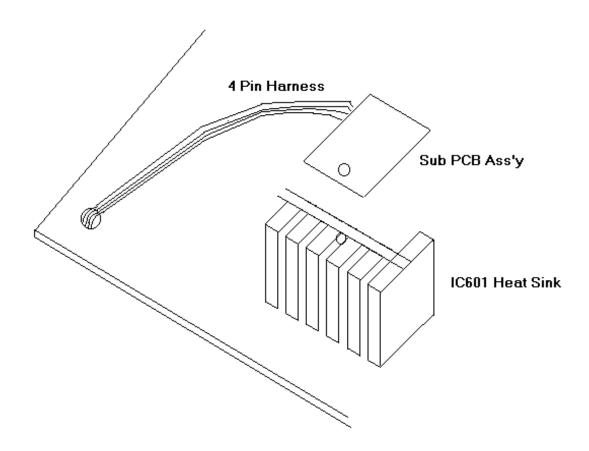
Figure 1

BACKGROUND: Q407 fails due to a transient pulse and current when mode switching from DOS to Windows. This occurs with a Matrox video card installed in the computer.

Top View of the Main Board

SOLUTION: Add a sub-PCB assembly as in figures 1 and 2 and a snubbing circuit for the horizontal output as in figure 3.

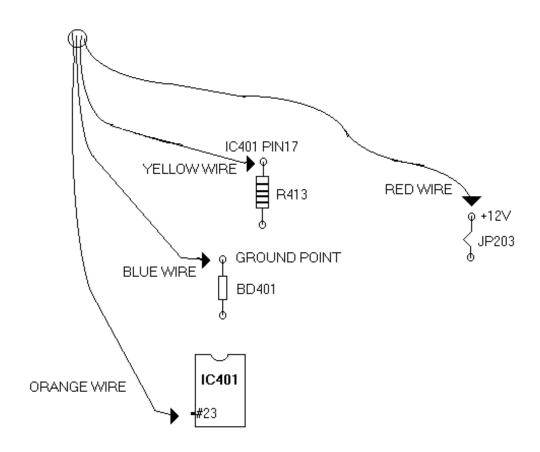
Figure 2

Bottom View of the Main Board
