# SERVICE BULLETIN

**PRODUCT: COMPUTER MONITOR**  
**BULLETIN: MONITOR 95-008**  
**MODEL: SAMTRON SC-428PT/L**

**SUBJECT:** No Raster

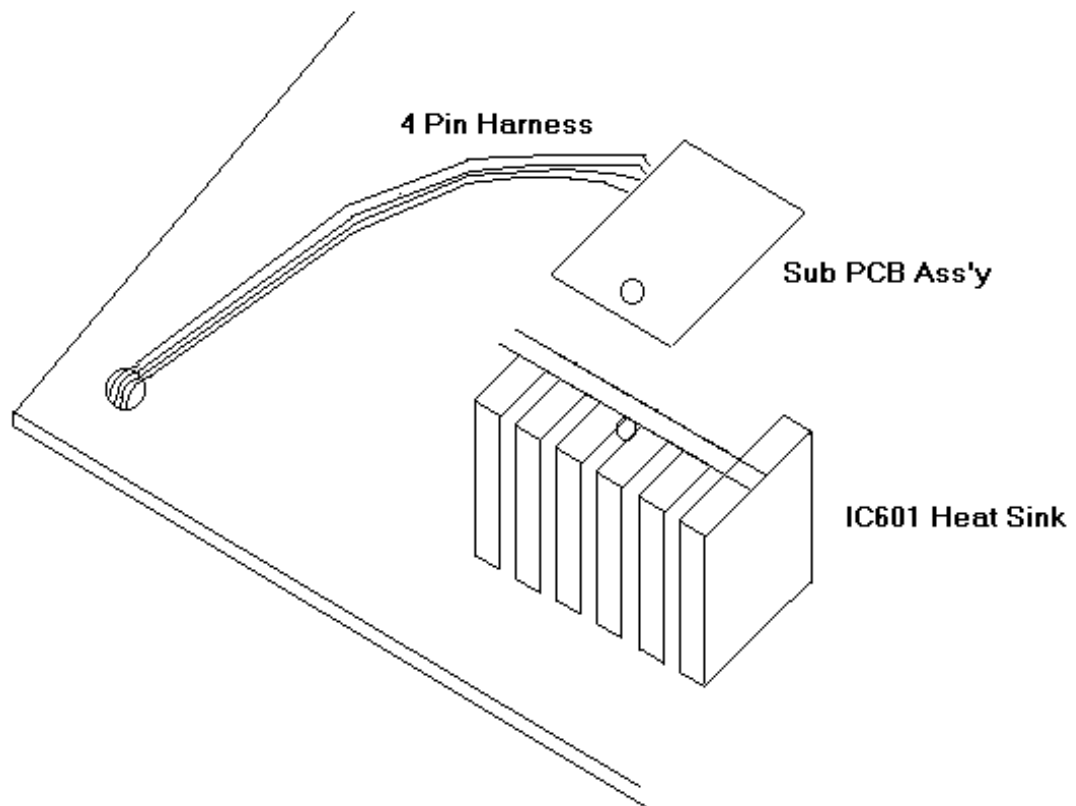
**Figure 1**

**BACKGROUND:** Q407 fails due to a transient pulse and current when mode switching from DOS to Windows. This occurs with a Matrox video card installed in the computer.

**SOLUTION:** Add a sub-PCB assembly as in figures 1 and 2 and a snubbing circuit for the horizontal output as in figure 3.
